# EAST TULLOS BURN RESTORATION

Draft Conditions Report

**Project Reference:** 2150541

**Document Type:** Conditions Report

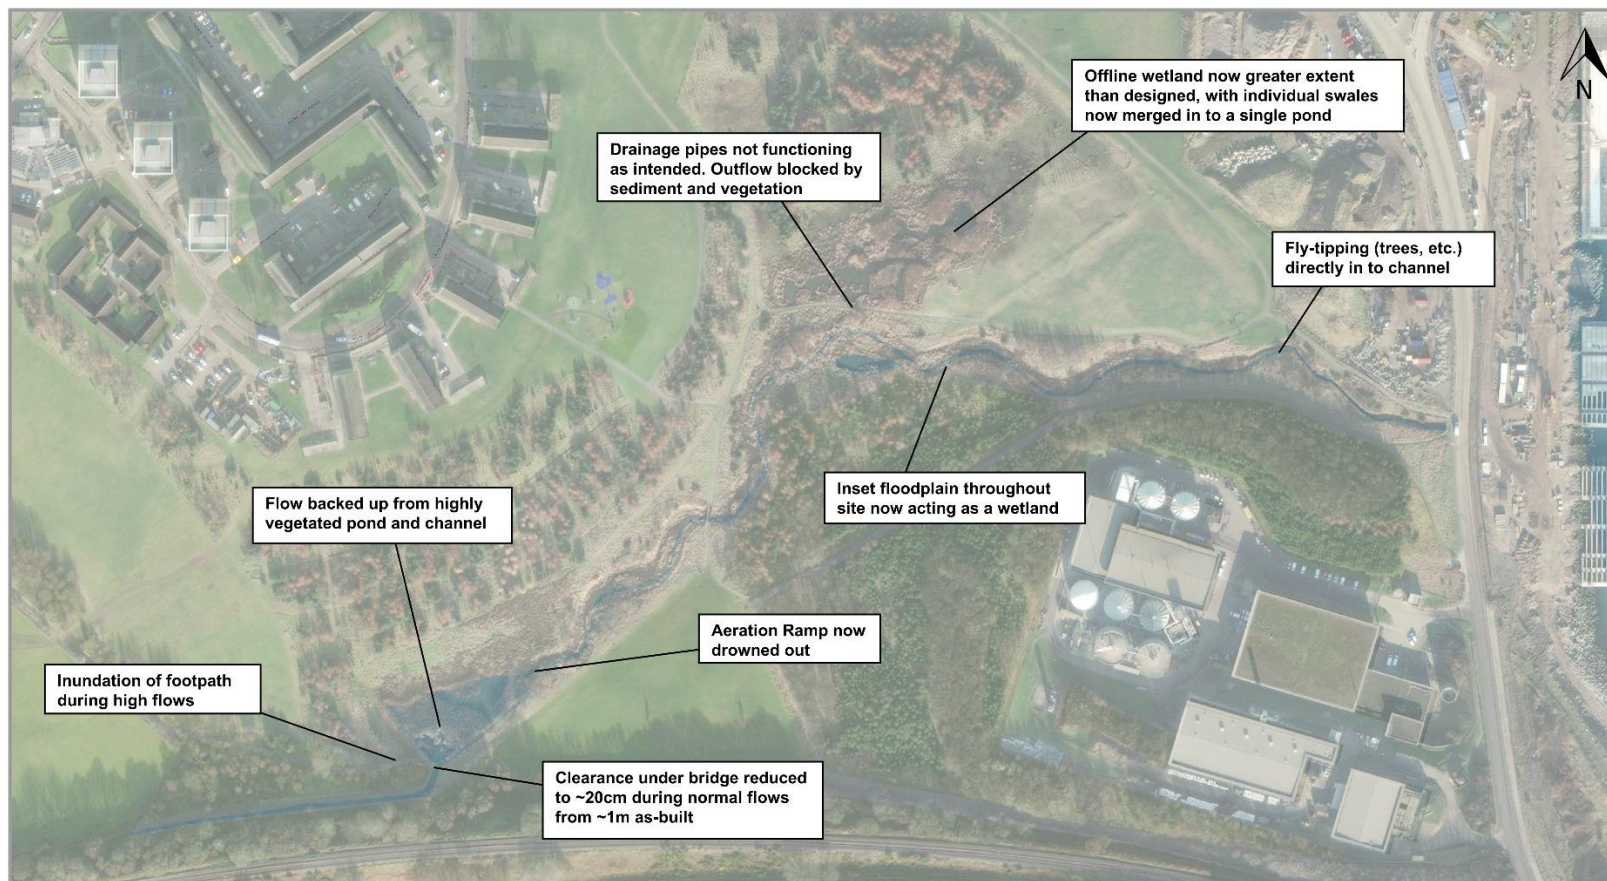
Figure 2.1. Site conditions overview

OS NGR Grid Reference	Description
n/a	No obvious zone of sediment supply upstream.
n/a	Bed of burn throughout site is sand.
NJ 9577 0449	Flow into the upstream end of the site is attenuated by a pond and culverts under the railway embankment.
NJ 9592 0452	Water backing up upstream from online wetland/ pond. Scottish water pipe outflow submerged (~10 m upstream of inflow to pond/ footbridge crossing).
NJ 9593 0453	Clearance on the bridge now reduced to 20cm max (had been >1m) at normal flows. At high flow now, the flow overtops the banks by the bridge and flows around the concrete bridge upstream of the upstream pond, causing inundation of public footpath.
NJ 9593 0454	Upstream area of the pond would need to be excavated to some extent (likely associated with some vegetation removal/ cut-back) to reduce water levels at the bridge and impounded flow upstream.
NJ 9597 0457	Aeration ramp downstream of online wetland/ pond outflow now drowned out. No appreciable velocity going over that ramp now. Flow backed up from highly vegetated channel/ inset floodplain downstream.

NJ 9607 0466	Water levels at mid-site footbridge also much higher than as built (from roughness effect of inset floodplain/ channel vegetation downstream backing water up).
NJ 9615 0476	Offline wetland – drainage pipes under path are clogged up (especially at outflow) and not functioning as intended. Offline wetland now greater in extent

than as designed although not necessarily a problem, and individual ponds/swales all merged into one feature but with a significant amount of vegetation.
n/a (site-wide)	Inset floodplain through entire site part now operating more like a wetland (not necessarily a problem).
NJ 9636 0474	Fly-tipping at downstream end of site – trees have been dropped into the channel.

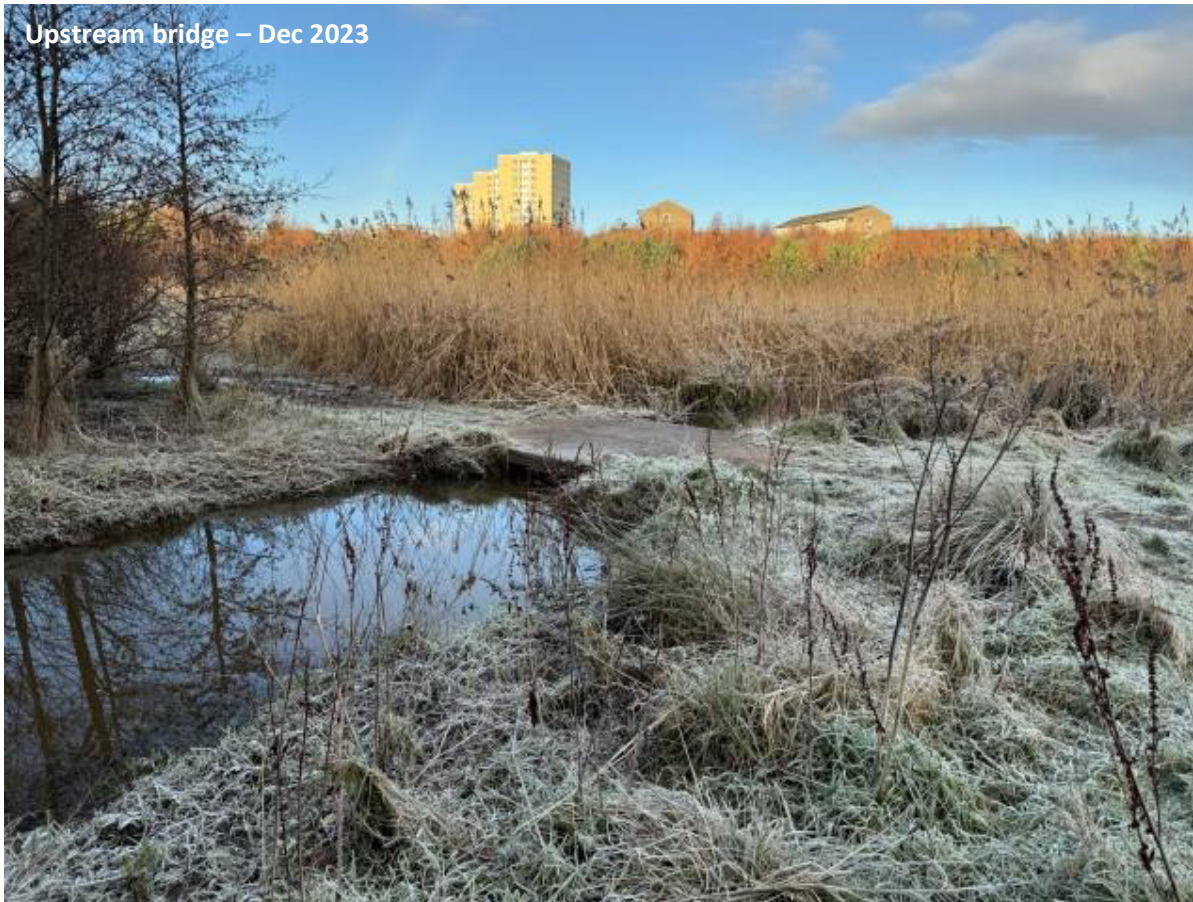
Upstream bridge – Dec 2023

- Siltation/sediment deposition issues throughout the site but particularly evident within the upstream online pond and at the upstream bridge crossing.
- Pipes that connect the channel to the offline wetland under the footpath in the middle section of the site are obscured and assumed to be constricted.
- The offline wetland is now larger in extent than originally designed, with the individual scrapes now merging into one large wetland (particularly noticeable in Figure 3.4).
- There is a dominance of single plant species in certain areas of the site.
- A significant volume of wood debris (not part of the restoration design) within the downstream extents of the previously realigned channel, upstream of the culvert to the harbour.
- A lack of species diversity has been noted, more evident within the upstream section of the site.
- Gorse is present within the downstream areas of the site.

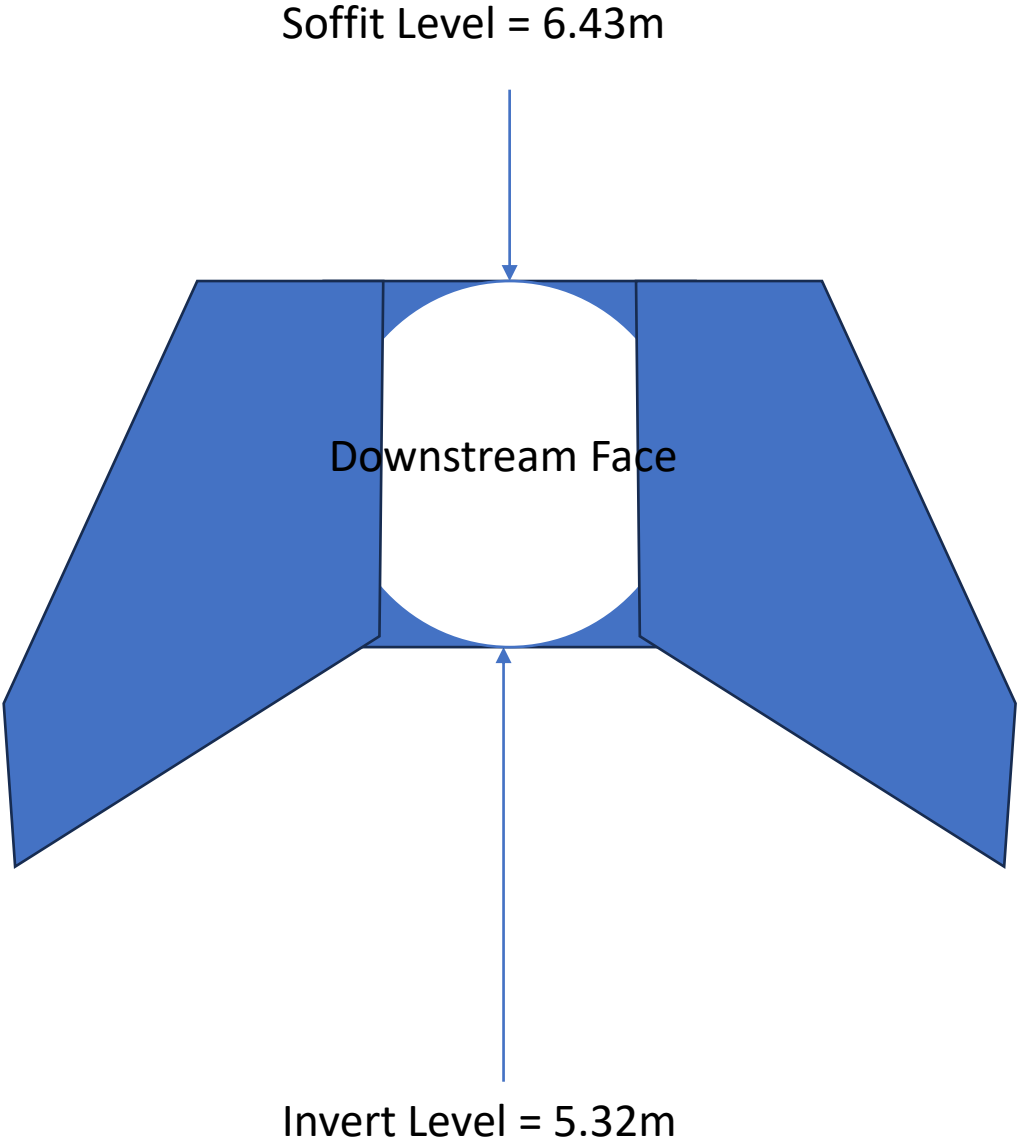
Upstream Face unable to be located.

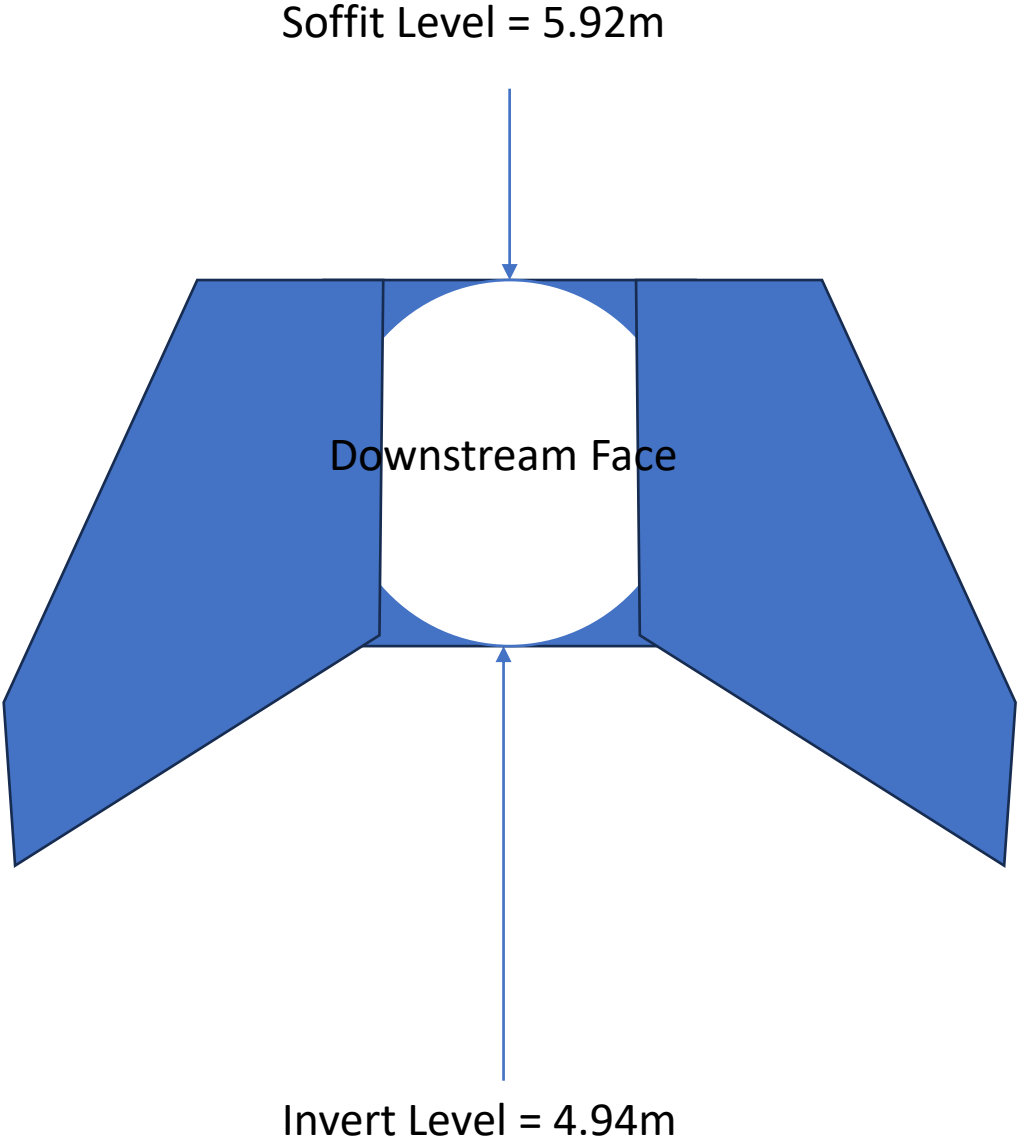
Upstream Face unable to be located,  
potentially drainage run off from industrial  
estate on other side of rail embankment

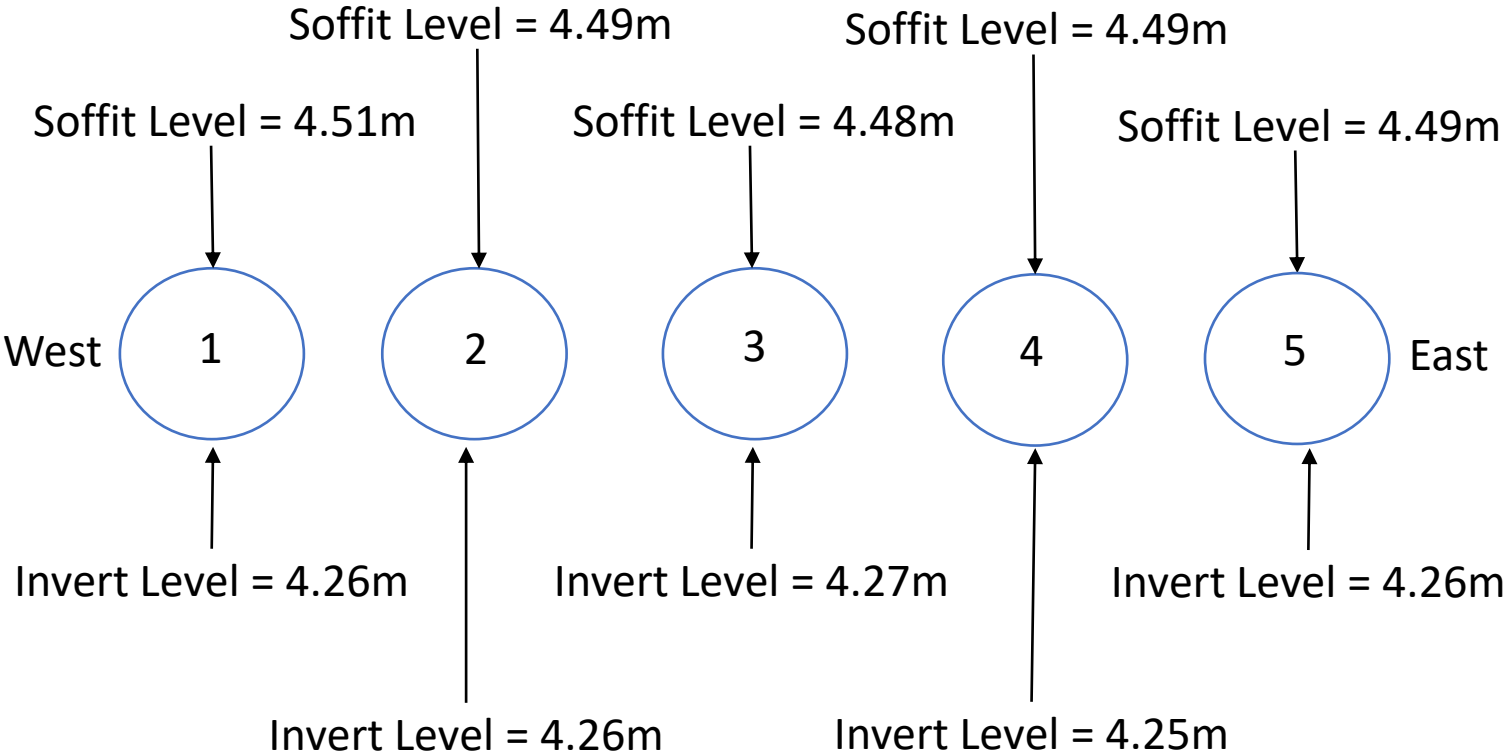
Pond Inflow Pipes Upstream - 396112 , 804761

No pictures as underwater and covered in silt

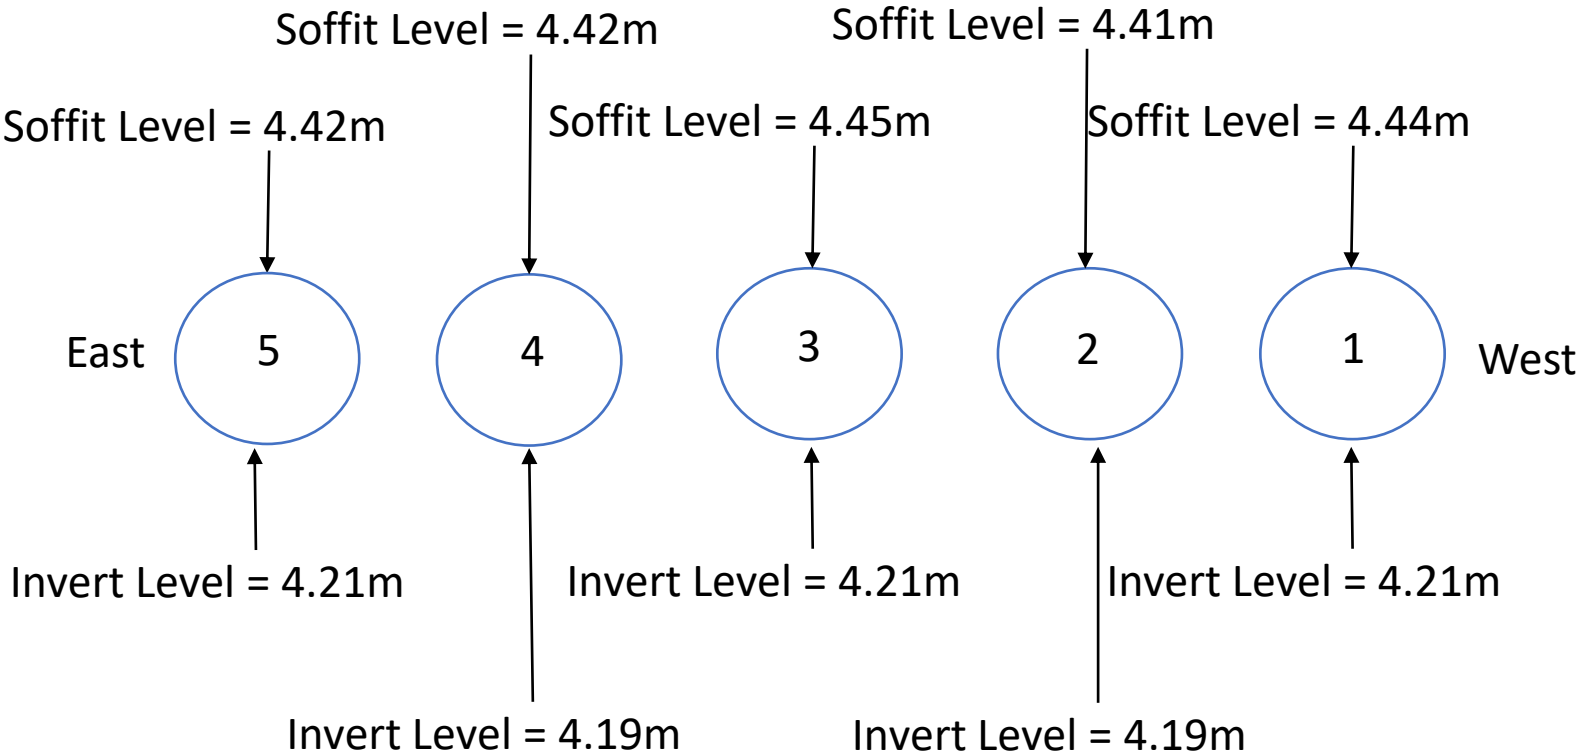
Pond Inflow Pipes Downstream - 396112 , 804765

No pictures as underwater and covered in silt

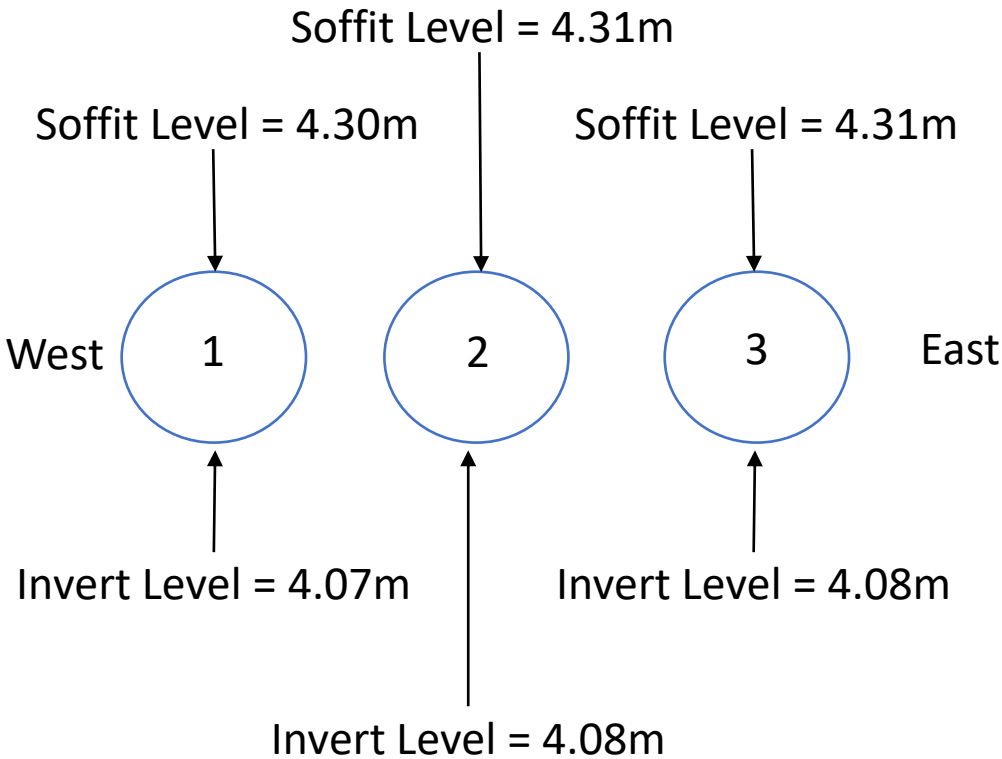
Pond Outflow Pipes Downstream - 396152 , 804761

No pictures as underwater and covered in silt

Only 3 pipes located, potential for more due to thick vegetation and silt layer

- 5. **Design:** potential clearing out of the pipes under the footpath that connect the channel and the offline wetland will be required – this should also be considered within the final maintenance plan for the wetlands.

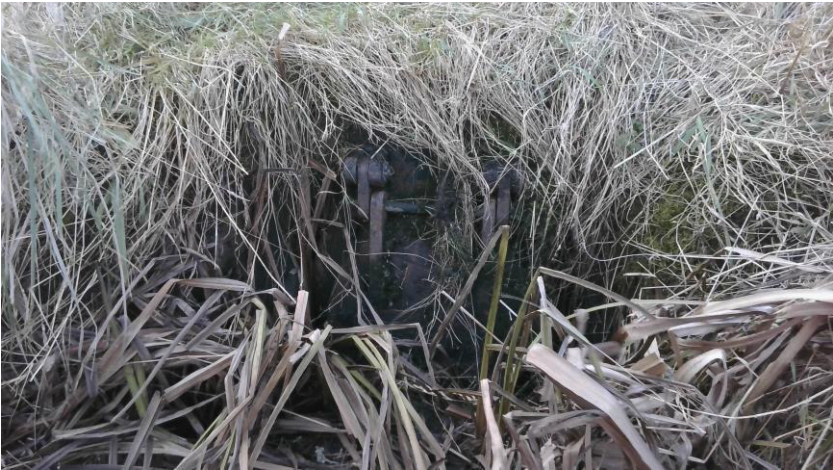
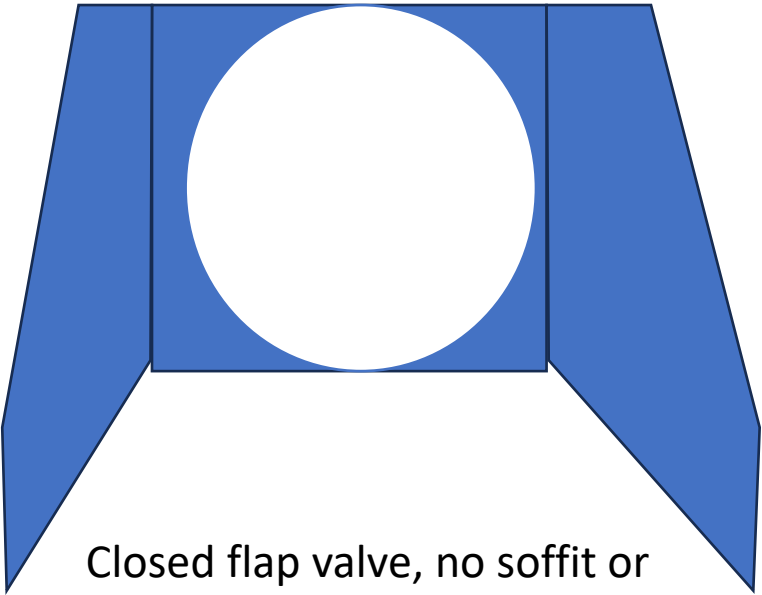
Closed flap valve, no soffit or invert possible
