# EAST TULLOS BURN RESTORATION

Draft Conditions Report

**Project Reference:** 2150541

**Document Type:** Conditions Report

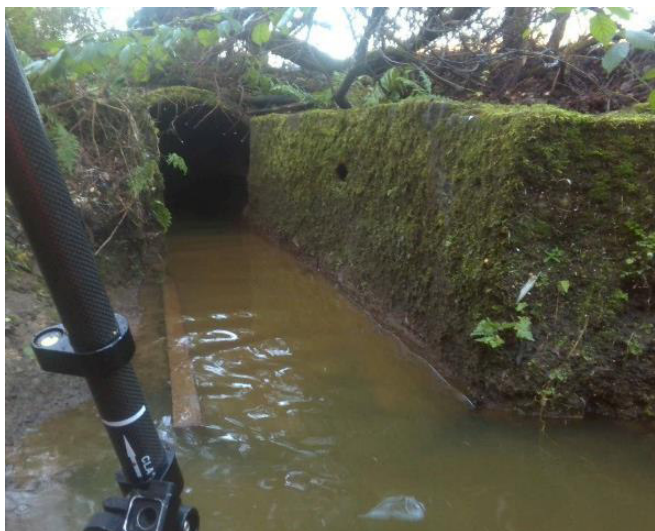
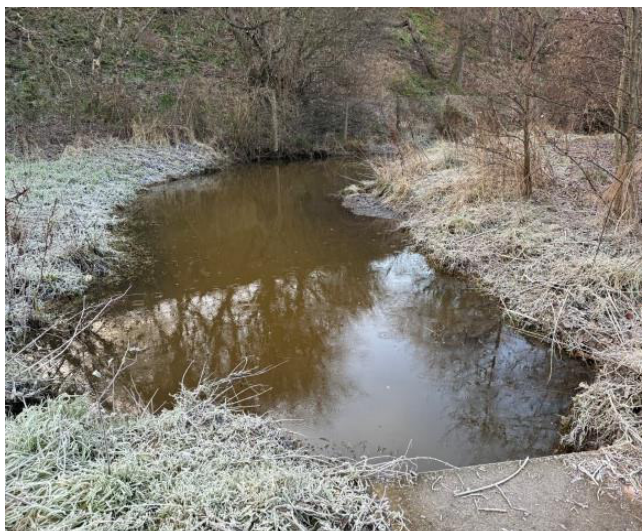
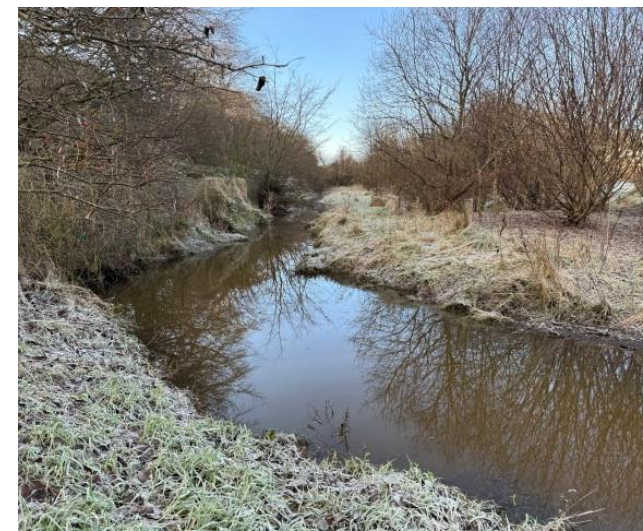
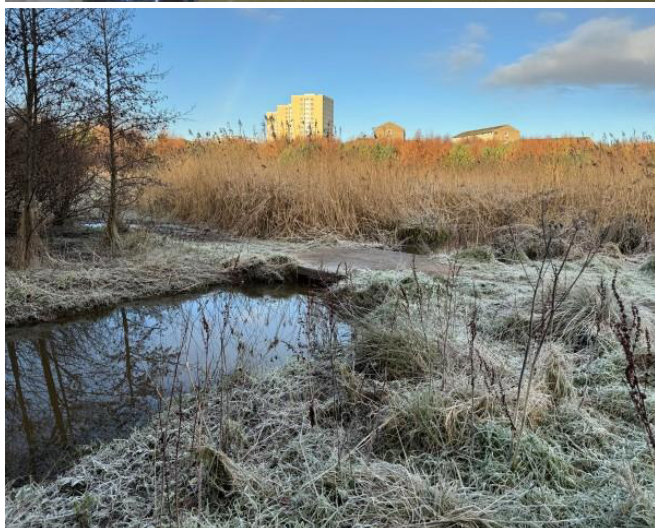
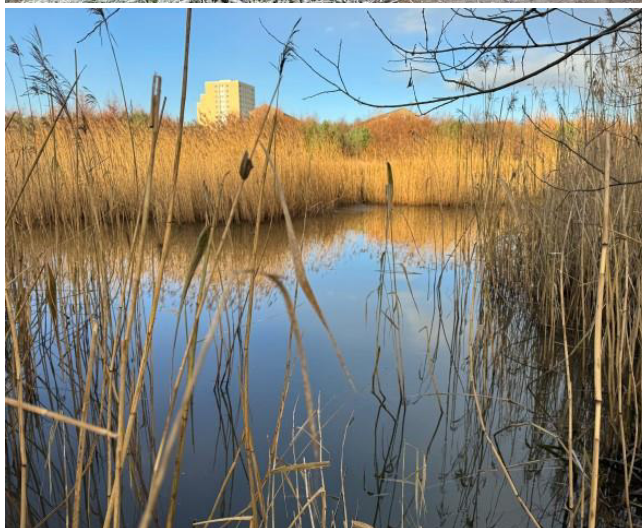
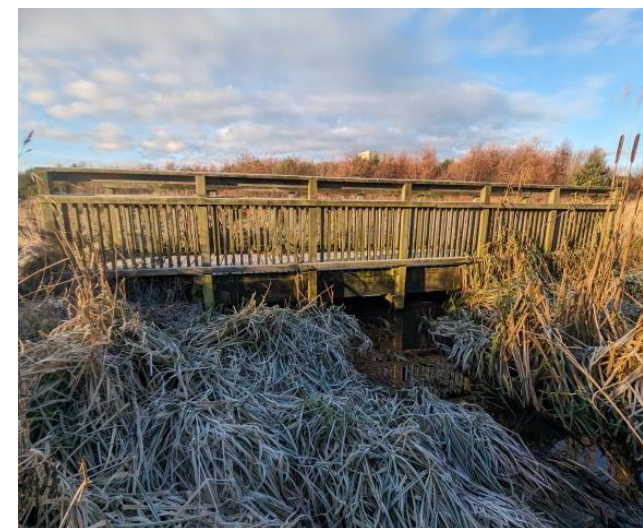
Table 2.2. Site photographs (December 2023)

OS NGR Grid Reference	Description
n/a	No obvious zone of sediment supply upstream.
n/a	Bed of burn throughout site is sand.
NJ 9577 0449	Flow into the upstream end of the site is attenuated by a pond and culverts under the railway embankment.
NJ 9592 0452	Water backing up upstream from online wetland/ pond. Scottish water pipe outflow submerged (~10 m upstream of inflow to pond/ footbridge crossing).
NJ 9593 0453	Clearance on the bridge now reduced to 20cm max (had been >1m) at normal flows. At high flow now, the flow overtops the banks by the bridge and flows around the concrete bridge upstream of the upstream pond, causing inundation of public footpath.
NJ 9593 0454	Upstream area of the pond would need to be excavated to some extent (likely associated with some vegetation removal/ cut-back) to reduce water levels at the bridge and impounded flow upstream.
NJ 9597 0457	Aeration ramp downstream of online wetland/ pond outflow now drowned out. No appreciable velocity going over that ramp now. Flow backed up from highly vegetated channel/ inset floodplain downstream.

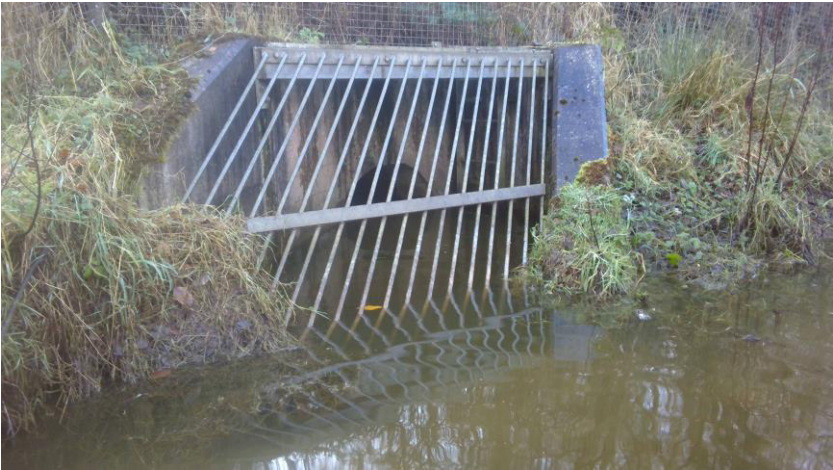
Culvert - 395869 , 804504

Upstream Face unable to be located,  
potentially drainage run off from industrial  
estate on other side of rail embankment

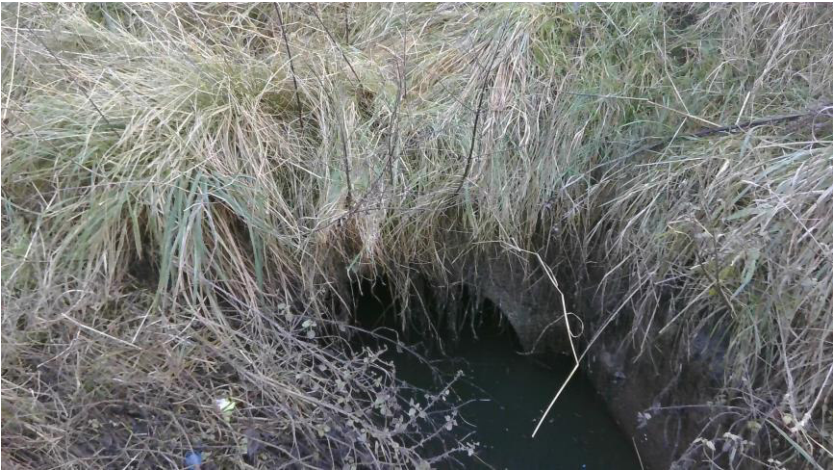
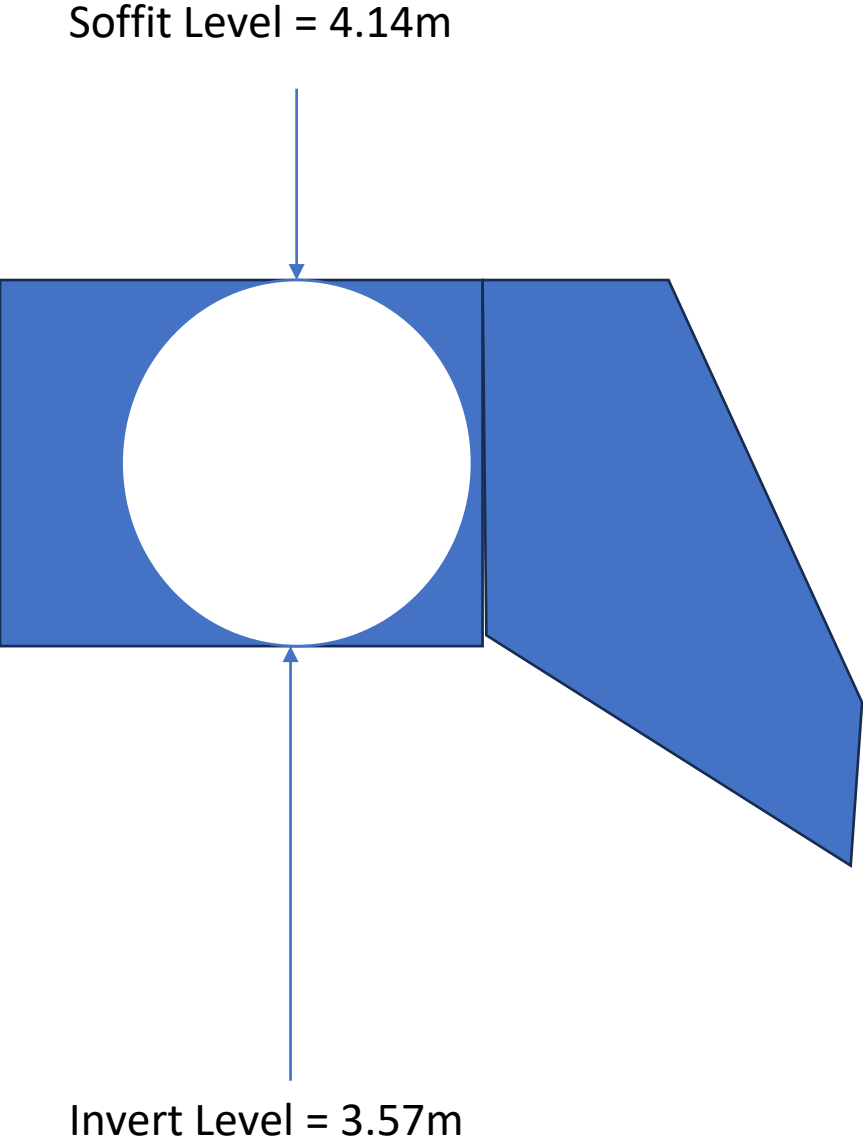
Downstream Face

Culvert - 396390 , 804732

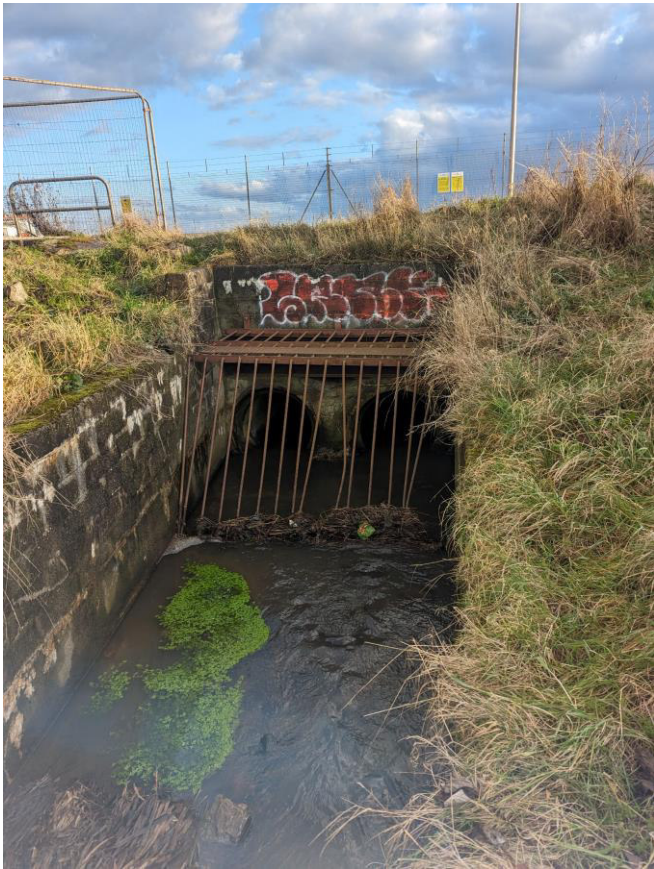
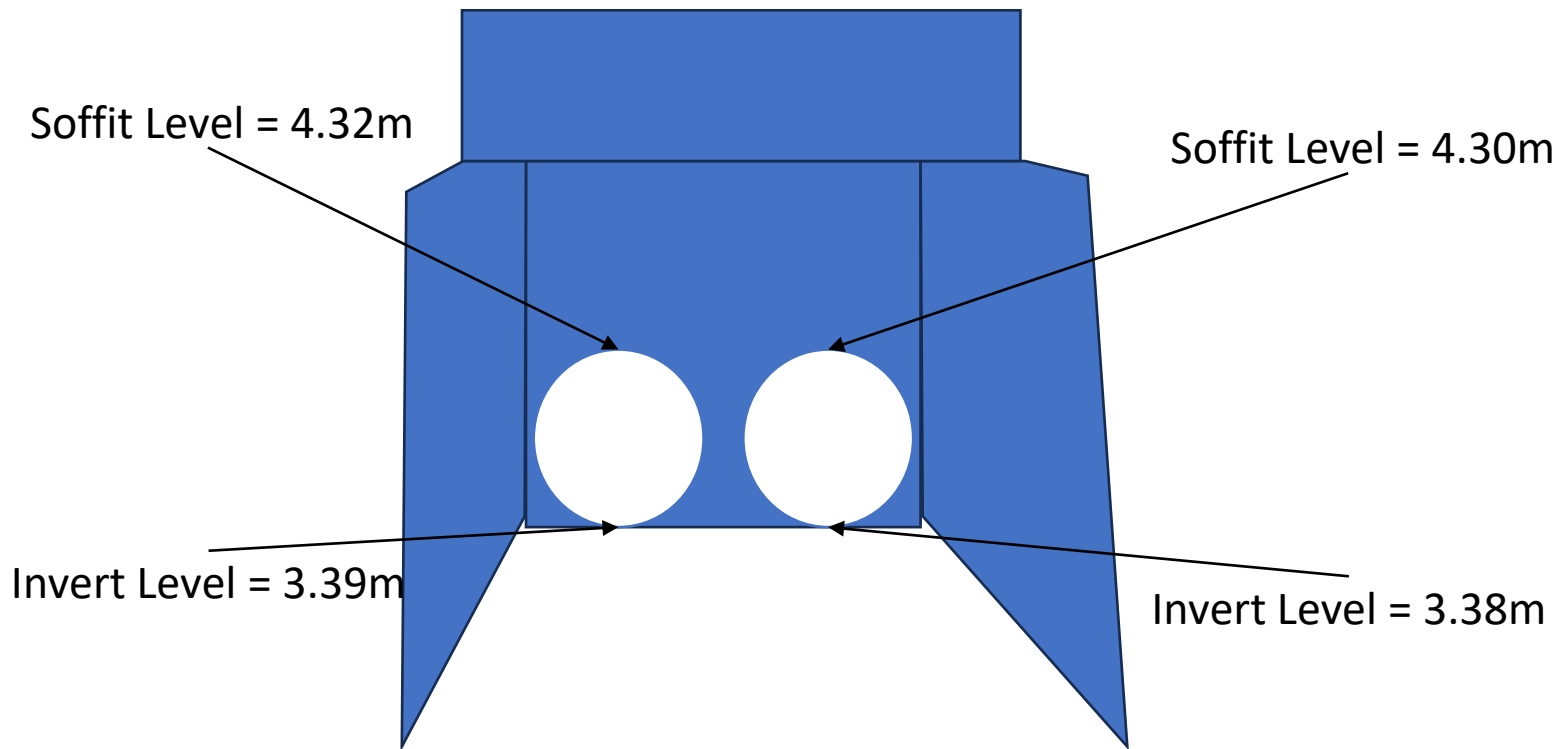
Upstream Face

No data on downstream face as it outfalls underneath the new docks.  
Design drawings provided by ETZ Ltd. Design also in chart datum -2.25 AOD).
